OPERATING EXPERIENCE WEEKLY SUMMARY

Office of Nuclear and Facility Safety

March 19 - March 25, 1999

Summary 99-12

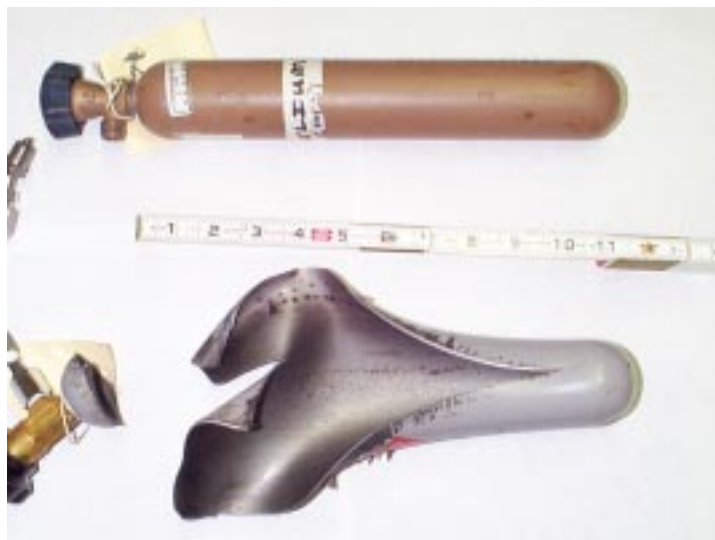
The FTTF is normally used for high-pressure experimentation and fracture studies of material samples, pressure vessels, and other components. It contains equipment capable of delivering pressures up to 30,000 psi. As a service to laboratory scientists, FTTF personnel occasionally use the facility to refill laboratory-size helium or hydrogen cylinders (lecture bottles). The cylinder that ruptured was rated for approximately 1,800 psi and was being filled to a target pressure of 1,700 psi. Facility personnel report that the failure occurred at an indicated pressure of approximately 1,500 psi. Figure 1-1 shows the failed gas cylinder.

Figure 1-1. Failed Gas Cylinder

Following a critique of the occurrence, facility personnel examined all of the cylinders on hand and determined that they were either empty or filled to the correct pressure. The facility manager ordered an investigation of the occurrence and immediately suspended all further pressurizations in the FTTF facility until corrective actions have been identified and implemented. Investigators determined that the only indication of fill pressure immediately available to FTTF operators during this operation is a digital pressure meter at a control station outside the test vault. Examination of this instrument showed that it had failed, and that actual pressure could have been more than five times the indicated pressure. Investigators also determined the following.

- Although the FTTF high-pressure manifold has rupture disk protection, the rupture disk was not adequately sized to provide protection for this type of cylinder. Thus, the failed digital pressure instrument was the single barrier to overpressurizing a cylinder.
- FTTF procedures require operability and calibration tests of pressure instrumentation in conjunction with test plans but do not require them before filling lecture bottles.
- FTTF personnel had not identified the need for a process hazards review for filling lecture bottles.

The FTTF manager has directed personnel to complete a system operating design review for the process of filling gas cylinders. During the critique of this occurrence, facility personnel identified the following corrective actions to establish defense-in-depth for cylinder filling operations.

- Establish a calibration procedure and frequency for the failed pressure instrument.
- Evaluate the need to install additional pressure relief capability.
- Perform a failure analysis of the digital pressure readout.
- Establish a filling operations log that identifies end-users.
- Evaluate the need to conduct a job hazard analysis for filling operations.
- Evaluate the need to establish shelf life and service test protocols for the gas cylinders.

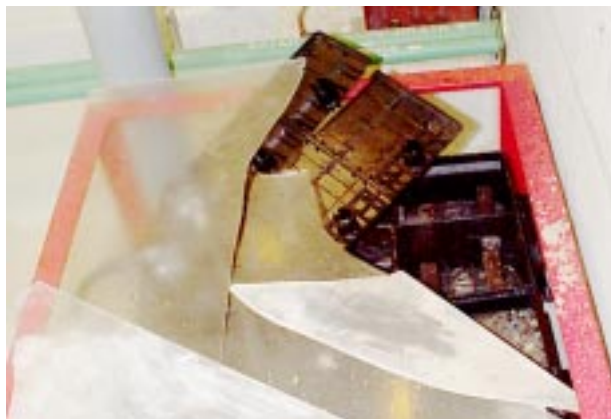
On March 8, 1999, at the Idaho National Engineering Environmental Laboratory Central Facilities Area, a utility operator was starting a diesel-driven fire water pump for a weekly test run when one of the associated batteries exploded. He was approximately 20 feet away when the battery exploded and spilled approximately 1 quart of acid on the concrete floor. The operator was not injured, so he secured the evolution and notified the appropriate supervisor of the explosion. A protective plastic covering over the battery bank was damaged when the battery exploded, as seen in Figure 2-1. No one had performed any inspection or surveillance of the facility fire water batteries since September 1997. Failure to perform inspections or surveillances on equipment that is required to be operable as part of the facility safety basis could violate the operational safety and technical safety requirements, which represent the minimum acceptable controls necessary to ensure safe facility operation. (ORPS Report ID--LITC-CFA-1999-0003)

Figure 2-1. Battery Bank and Damaged Plastic Cover after Explosion

- The electrolyte in the battery that exploded was low.
- The bus bar in the battery that exploded was fractured and some corrosion was found in the break area.
- The facility fire water pump batteries are 5 years old.

Facility personnel contacted the battery manufacturer and discussed the event. They believe that low electrolyte contributed to the lead corrosion and that the corrosion led to volume expansion inside the battery, causing the bus bar to experience unexpected mechanical forces and to fracture. They also believe that the arc and the cell case rupture occurred when the operator attempted to start the pump, because of the fractured bus bar. In addition, some manufacturers recommend replacing these types of lead-acid batteries every 5 years. The facility manager directed facility personnel to switch to nonleaded acid batteries.
